Immediate loading of a Neoss ProActive® Tapered implant to correct upper right lateral incisor agenesis.

Dr. Roberto Romano, Italy

Treatment plan: Placement and immediate loading of a Neoss ProActive® Tapered implant restored with a screw-retained zirconia crown.

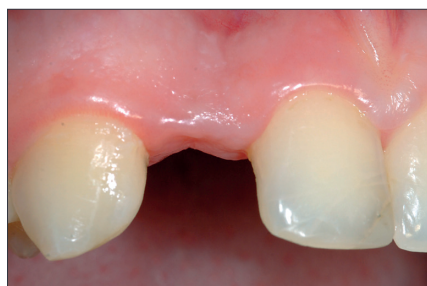
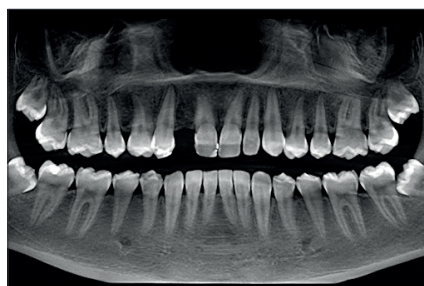
The patient needed an implant to replace the upper right lateral incisor missing due to agenesis (Figure 1 and 2).

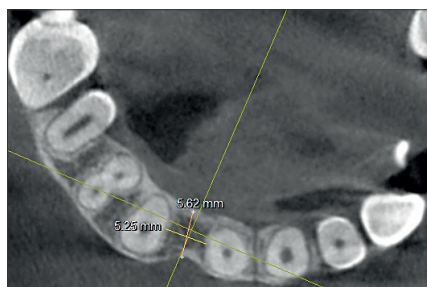
The CBCT scan showed a residual bone width of 5.6 mm in the palatal-buccal and 5.2 mm in the mesio-distal direction (Figure 3 and 4).

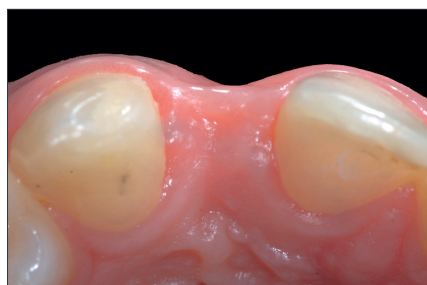
Figure 5

Although the amount of bone was sufficient for implant placement, the soft tissue on the buccal aspect showed a concave profile (Figure 5).

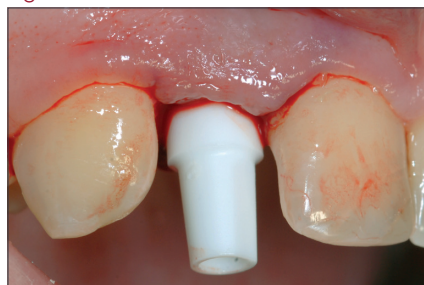
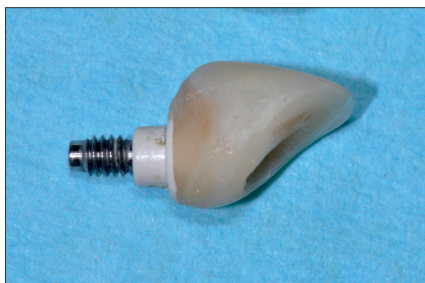
A screw-retained provisional crown previously manufactured by the lab was adapted to a Neoss Esthetic Tissue Former – Narrow Incisor (Figure 8 and 9).

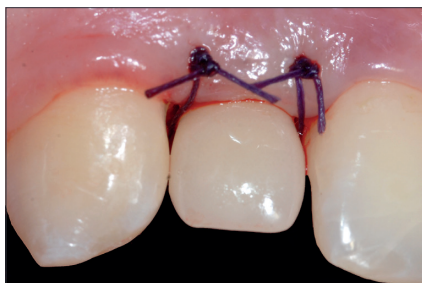
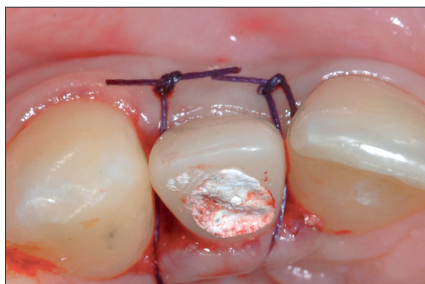
The crestal incision was slightly palatally displaced in order to correct the lack of soft tissue on the buccal aspect when the flap was sutured (Figure 10 and 11).

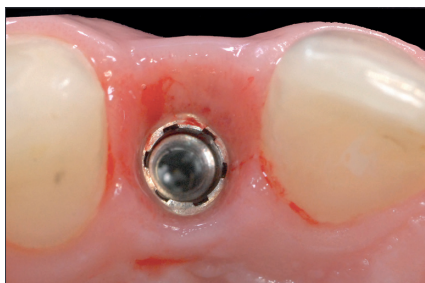
The concave aspect of the soft tissue on the buccal aspect appears corrected after 3 months of healing (Figure 12 and 13).

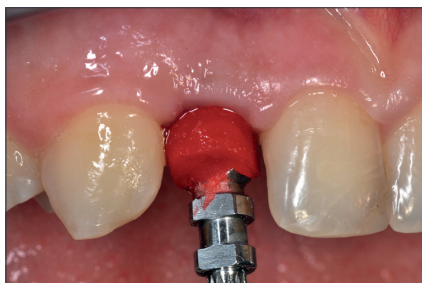
Figure 14

Final impression was taken with a customized impression coping aimed to replicate the trans-mucosal path shaped by the provisional crown (Figure 14).

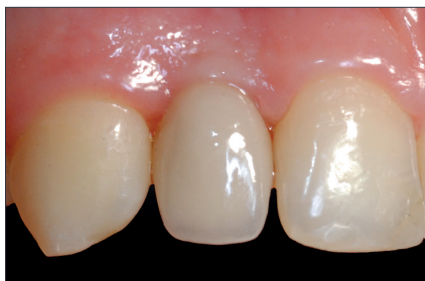
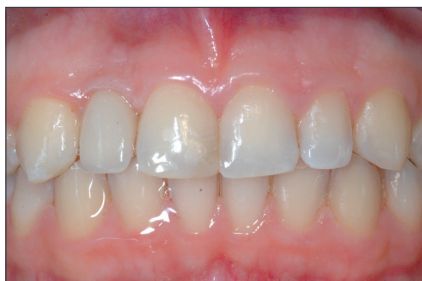
The final restoration was a zirconia abutment with ceramic layered on the buccal aspect (Figure 15 and 16).

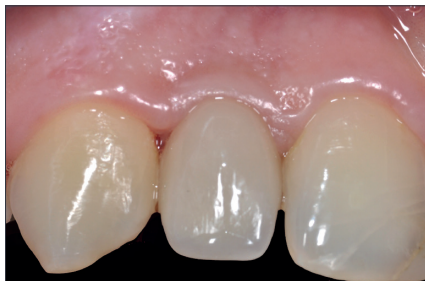
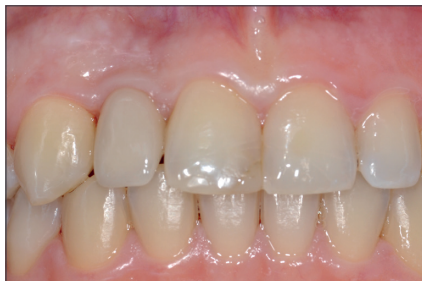
After 3.6 years from the definitive restoration delivery, soft and hard tissue levels were stable and the esthetic aspect was satisfactory (Figure 17 and 18).
